E
96.004

**The Ponds of Sint-Maarten
Sustainable Development and Management**

Report prepared for the Department of VROM
Sint-Maarten

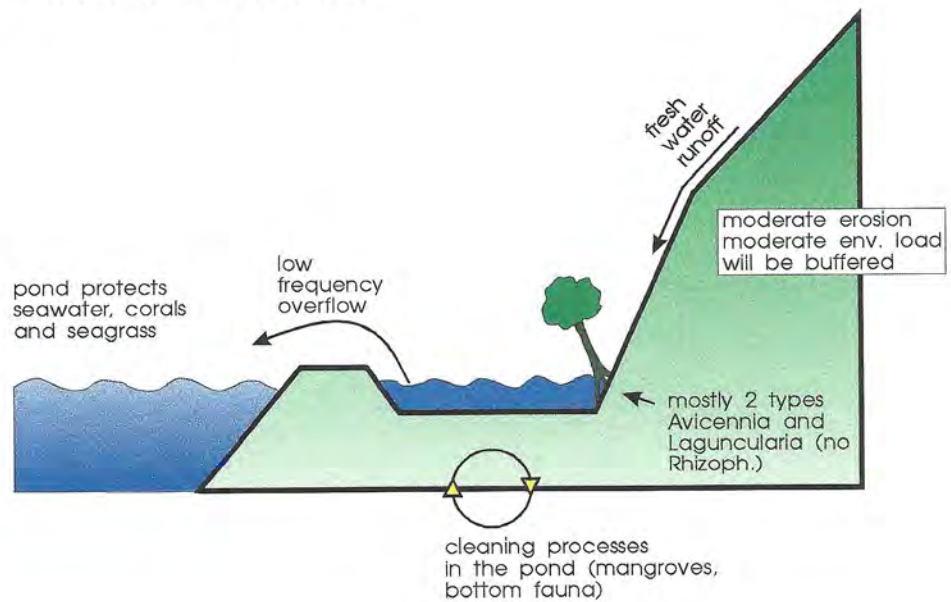
Figure 2.1 Ecological and environmental function of the ponds

Ecological function
(optimal)

(optimal)
Environmental function

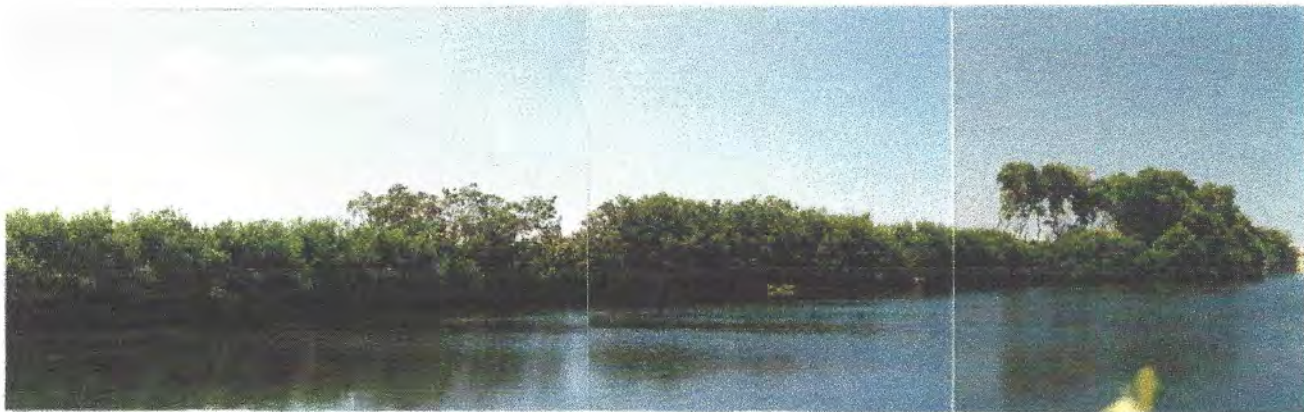
Flamingo Pond

1. Flamingo Pond, a relatively large natural area near the airport will be given up for the purpose of the extension of the airport. Other areas will be designated to compensate for this loss.

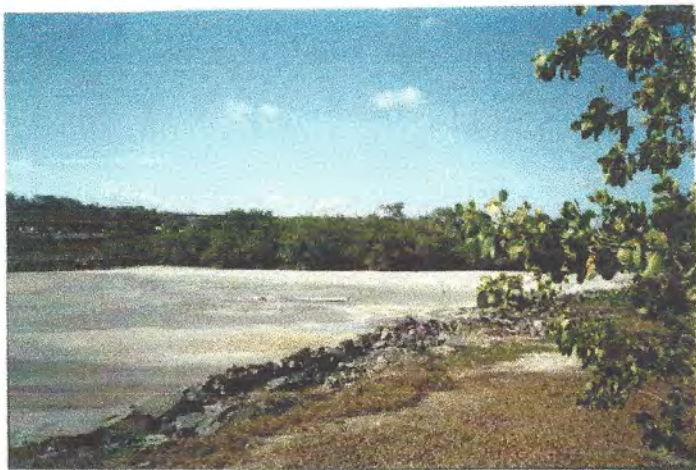
- ▲
2. A small, nearly dried up pond is located south of the airport and Flamingo Pond. The pond is threatened by the continuous need for expansion of the airport. A lot of building waste is discarded at the backs of the pond.

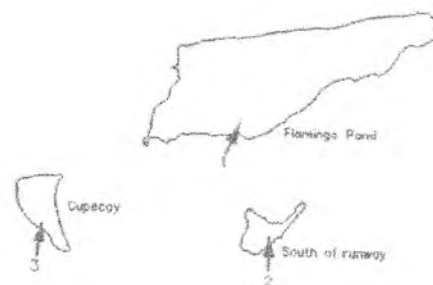
3. Close to Cupecoy, another small pond is situated. This pond is surrounded by a dense fringe of mangroves. Because of a surface connection with Simpson Bay Lagoon the pond has an important nursery function for marine waters.

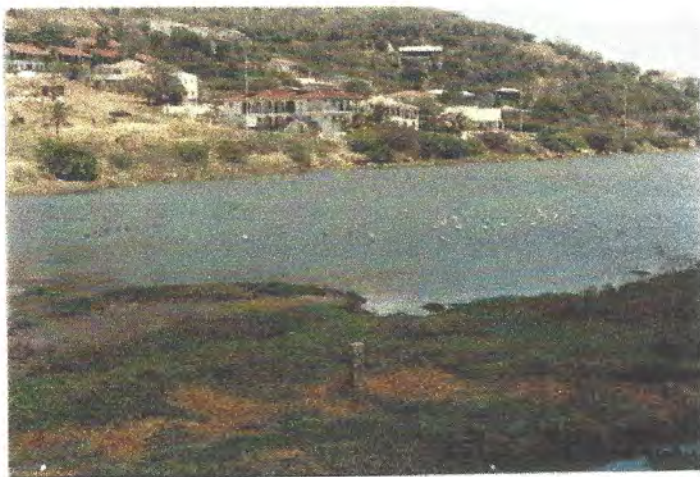
▲
2. Despite the water quality and low vegetation diversity, the Little Bay Pond harbours considerable numbers of foraging waterfowl, such as snowy egret, White Egret, Bahama pintails and blackwinged avocet.

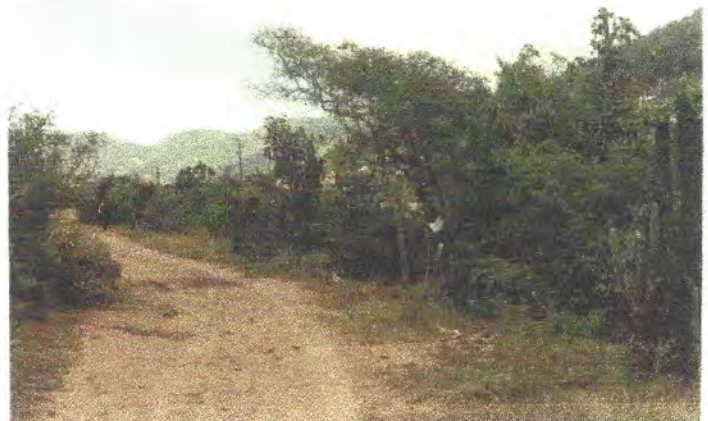
3. An unpaved road stretches along the west side of Little Bay Pond. Apparently, the road was cut out through original hill vegetation, which can still be observed along the pond (right side). Parallel to this road an inundated road exists in the pond. This shallow part is expected to provide an excellent site for mangrove restoration

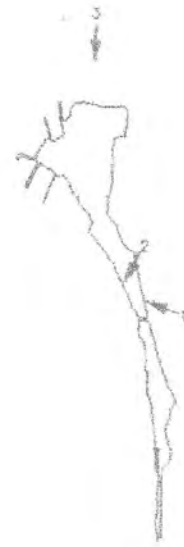
3. This aerial picture shows the Fresh Pond with the north side in the lower part. On the upper left side part of the Great Salt Pond can be seen, bordered by the town of Philipsburg. Note the difference in watercolor.

Monitoring of the pond during the period February-March¹ 1995 revealed high concentrations of nutrients (phosphates, nitrate and ammonium), however not as high as in the Fresh Pond. Oxygen concentrations were found to fluctuate less, indicating less activity of algae. This is in accordance with the clarity of the water of the Salt Pond compared to that of the Fresh Pond (photograph 2 Fresh Pond).

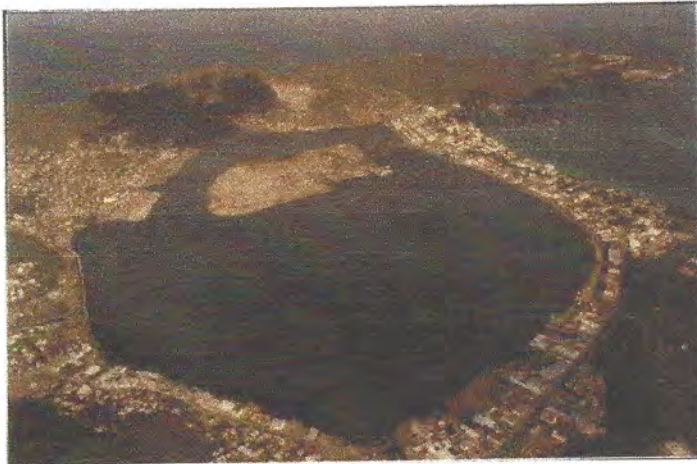
2. Aerial picture, showing the Landfill, Philipsburg, Great Bay and part of the Fresh Pond.

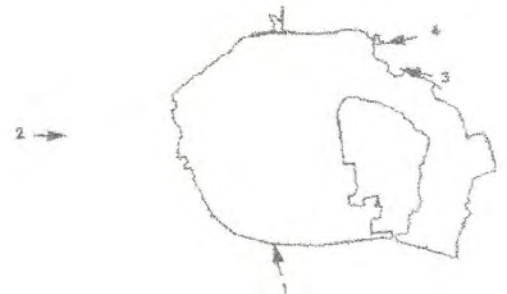
3. On the east side, a brackish waterbody between filled areas is almost overgrown with saltwort, and forms a habitat for (mainly) snowy egret.

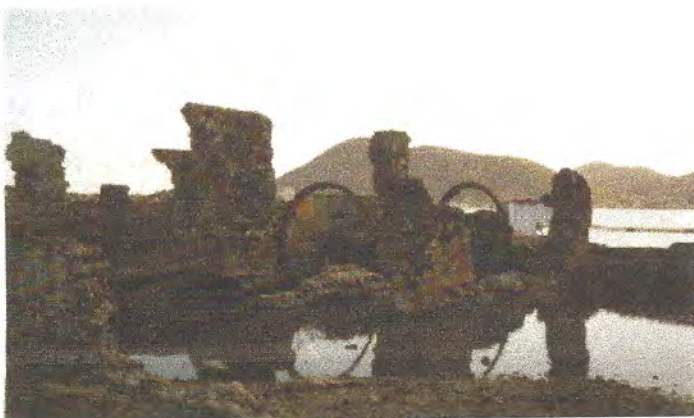
4. After restoration, the ruins of the salt factory could form an educational, historic site for both tourists and islanders.

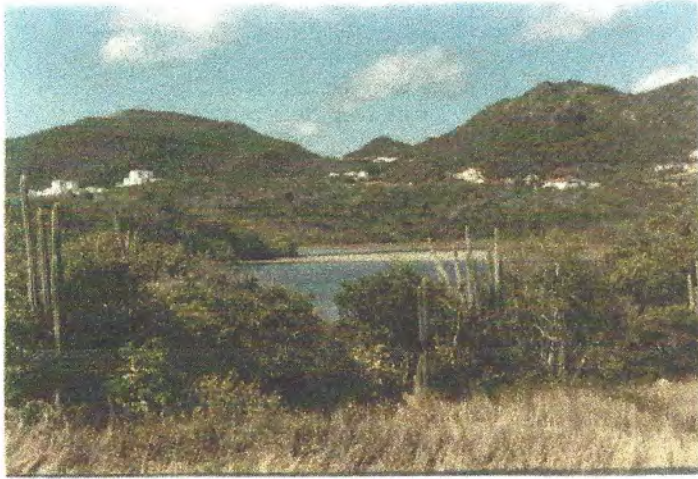
2. The picture was taken from the hillside north of the Red Pond. The hillsides are mostly covered with vegetation. However, some sandy roads intersect the area. Several houses are scattered on the hillsides.

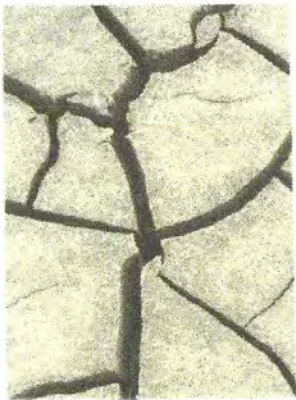
3. The picture shows the Red Pond from the north side. The watercontent is dependent on the rainfall. When no rain falls for an extended period, the pond dries up.

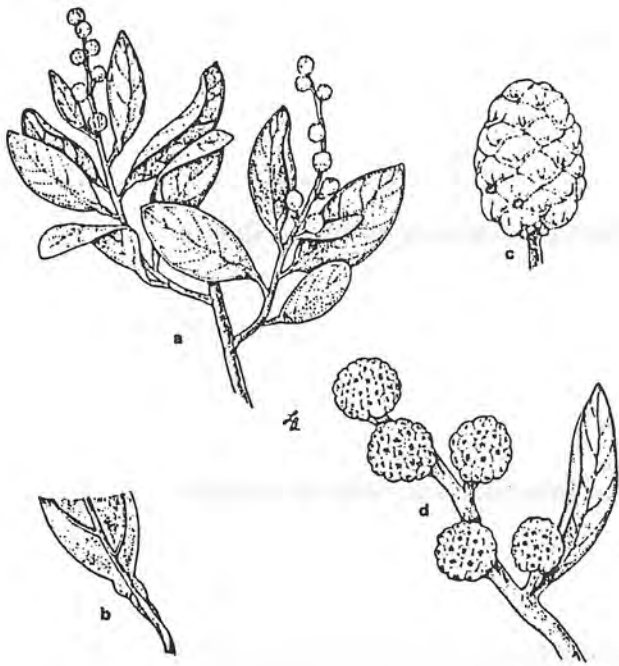
The habit of the buttonwood *Conocarpus erectus* a) Vegetative branch and young flowers. b) The base of the leaf showing salt glands. c) An aggregate of flowers. d) The developing woody fruits

The buttonwood tree does not possess stilt roots or pneumatophores, nor does it exhibit vivipary, and is regarded by some as not being a true mangrove. It appears to be tolerant to a variety of conditions. The tree has alternate leaves and the fruit is a persistent woody aggregate. This plant is found at the highest elevations of a mangrove swamp.

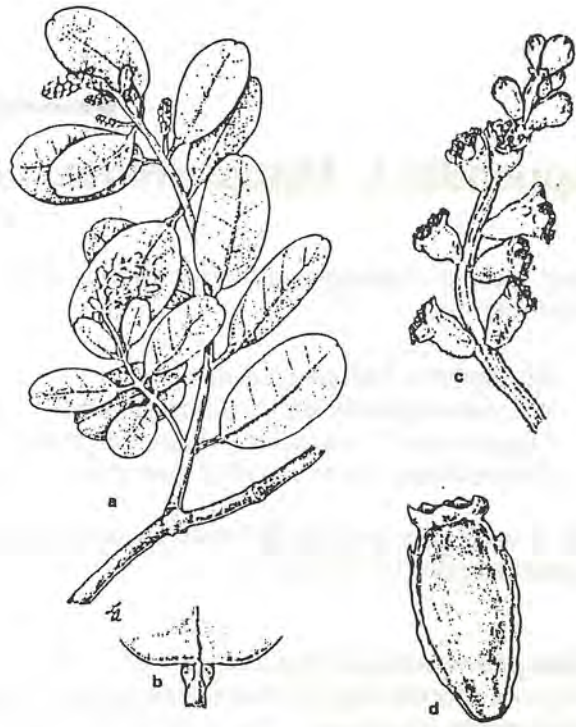
The habit of the white mangrove *Laguncularia racemosa* a) Vegetative branch with flower buds. b) The base of the leaf showing the 2 salt glands characteristic for the species. c) An raceme of flowers. d) The fruit

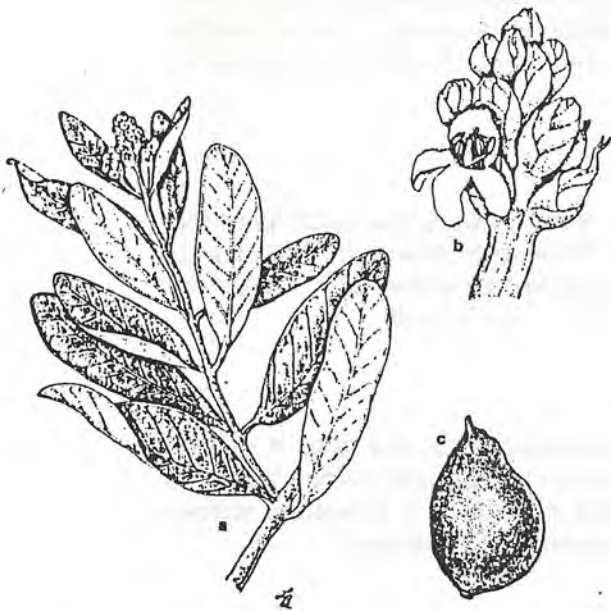
The habit of the black mangrove *Avicennia germinans* a) Vegetative branch and young flowers. b) A floral cluster. c) A mature fruit
